Analysis of Pavement Failure (Flexible Foundation): A Case Study of Bauchi-Kaduna

Abdulmajid Ibrahim¹, Engr. Yusuf Yau², Ewemade Cornelius Enabulele³

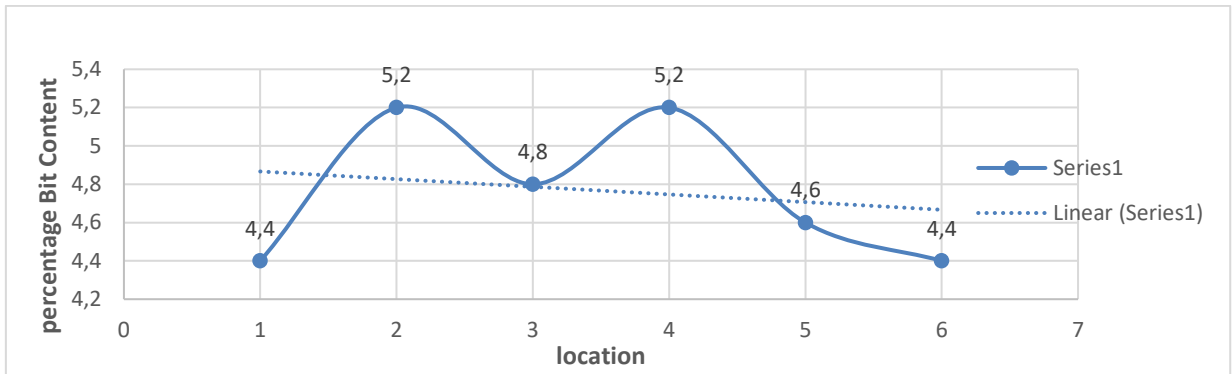
Figure 7: A graph of percentage bit content against location

The above analysis met the most significant requirements: void content, stability flow, and bitumen content. Observed that because enough filters were generally used, voids content was kept within specification requirements, although the aggregate grading was slightly out of the upper limit in a few locations.

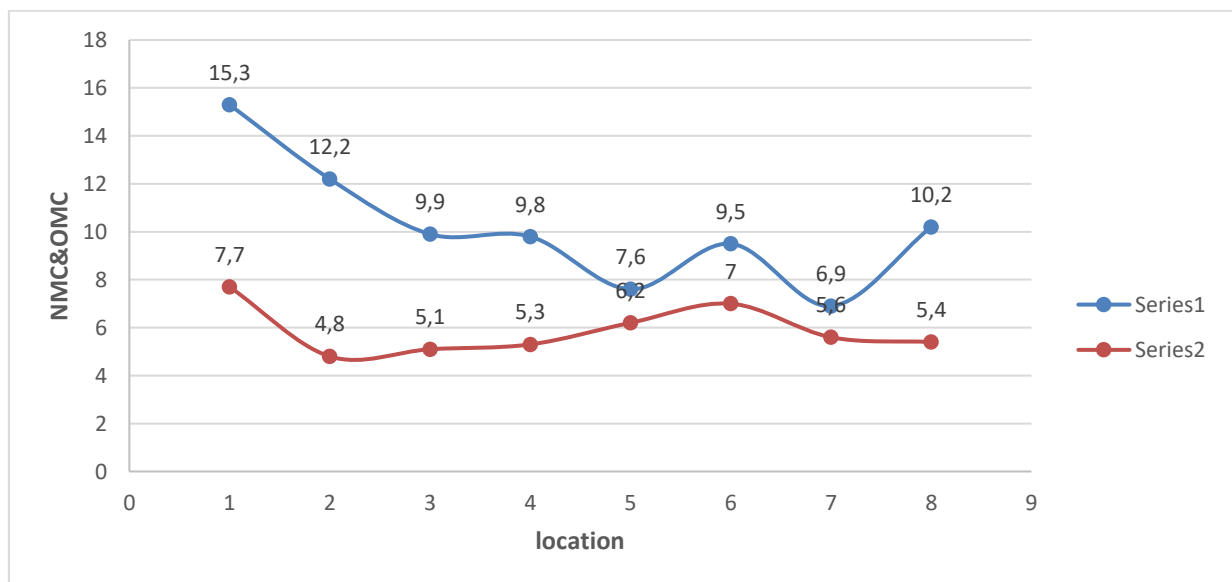
Figure 12: A graph of NMC & OMC against the location

It is reasonable to state that, like in the failed section, it is unsuitable in the base of the sound Section. They are also mainly clayey materials, and it is observed that failure did not occur in these sound sections because the natural contents are below the optimum moisture contents even during the rainy season.

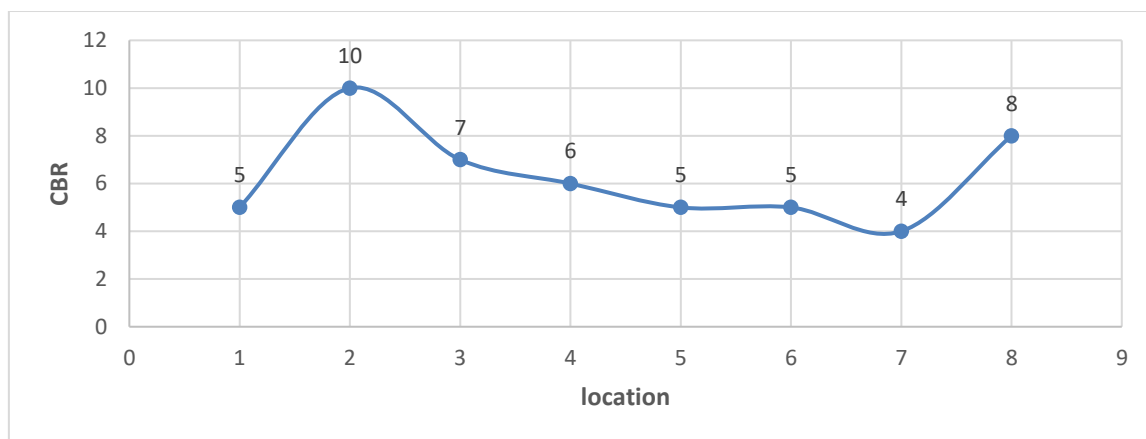
Figure 14: A graph of CBR against location

From the analyses, the subgrade soils encountered have acceptable levels of liquid plasticity index and subgrade in most locations. However, their particulars are too fine as the proportion passing BS Sieve No 200 was higher than in all the tested samples. They are mainly clayey soil of A-2-7, A-6, A-7-6, and AASHTO classification groups, which also undergo swelling and shrinkage characteristics upon variation in moisture contents.

It can be inferred that soil of the same characteristics was encountered in the sound and failed sections, but failure did not occur in sound areas because they were dry even under the rains due to good drainage and the use of suitable stone base.
