Analysis of Pavement Failure (Flexible Foundation): A Case Study of Bauchi-Kaduna

Abdulmajid Ibrahim[1], Engr. Yusuf Yau[2], Ewemade Cornelius Enabulele[3]
[1,2]Ahmadu Bello University Zaria, Nigeria
[3]Federal University of Technology Akure, Ondo State, Nigeria
majd4real@gmail.com; yyau@abu.edu.ng

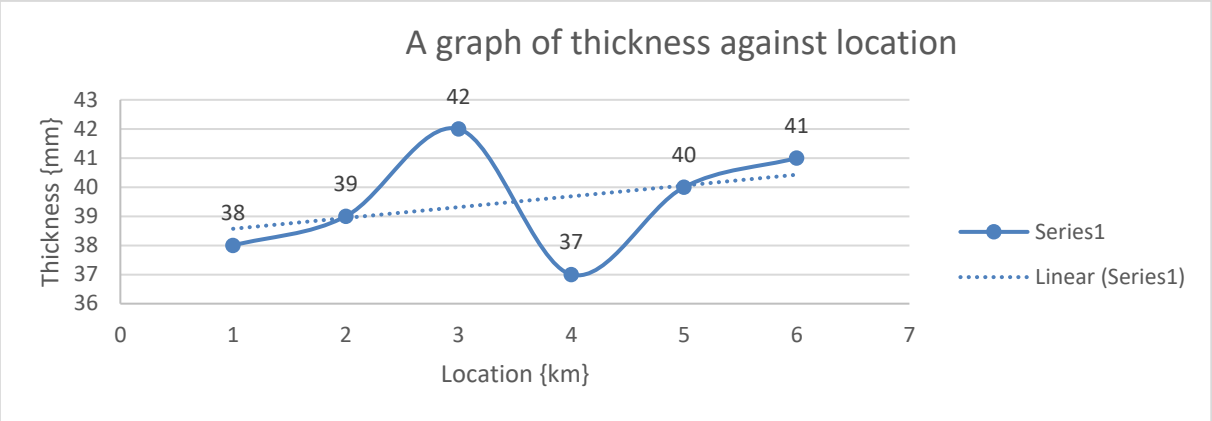
Figure 3: A Graph of thickness against location

S/N	Location	Thickness	BDG	MSD	%Void	Mar.Stab	Mar. flow	BitCont,	Remark
1.	8+300	38	2.36	2.51	5.5	778	4	5.3	Sound
2.	8+600	39	2.45	2.53	56.3	832	5	5.5	Sound
3.	8+900	42	2.34	2.47	5.3	621	4	5.7	Sound
4.	9+200	37	2.44	2.51	5.1	742	3	5.1	Sound
5.	9+500	40	2.36	2.52	5.8	681	3	4.9	Sound
6.	9+800	41	2.52	2.52	6.1	589	4	5.2	Sound

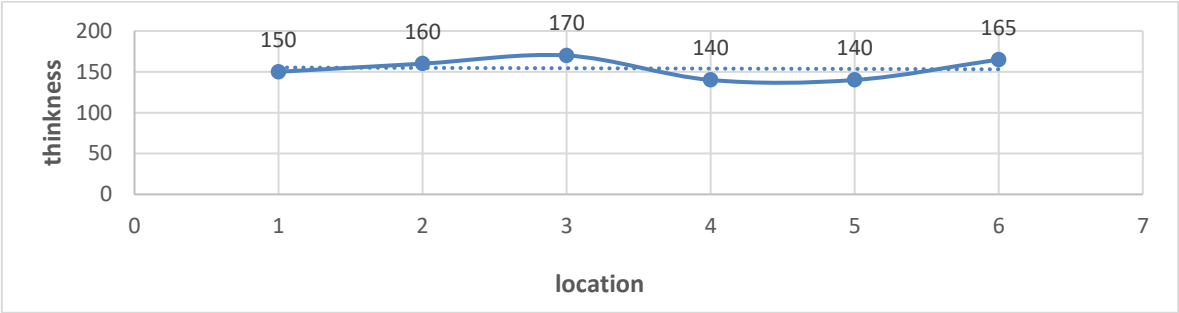
Figure 11: A graph of thickness against location

S/N	Location	Thickness	INSITU TEST		LAB TEST		ATTERBERT				ASHTON CLASS
			NMC	DENS	NMC	OMC	#36	#200	LL	PL	
1.	8+300	150	3.3	2.213	2.17	4.4	6	0.1	28	12	A-2-6(0)
2.	8+600	160	5.9	2.224	2.188	5.8	11	0.13	37	13	A-2-6(0)
3.	8+900	170	5.9	2.286	2.165	5.8	5	0.1	33	13	A-2-6(0)
4.	9+200	140	8.4	2.125	2.16	6.6	11	0.2	34	10	A-2-4(0)
5.	9+500	140	3.1	2.16	2.16	6.7	13	0.4	27	13	A-2-4(0)
6.	9+800	165	6.9	2.03	2.15	7.4	11	0.3	28	9	A-2-4(0)

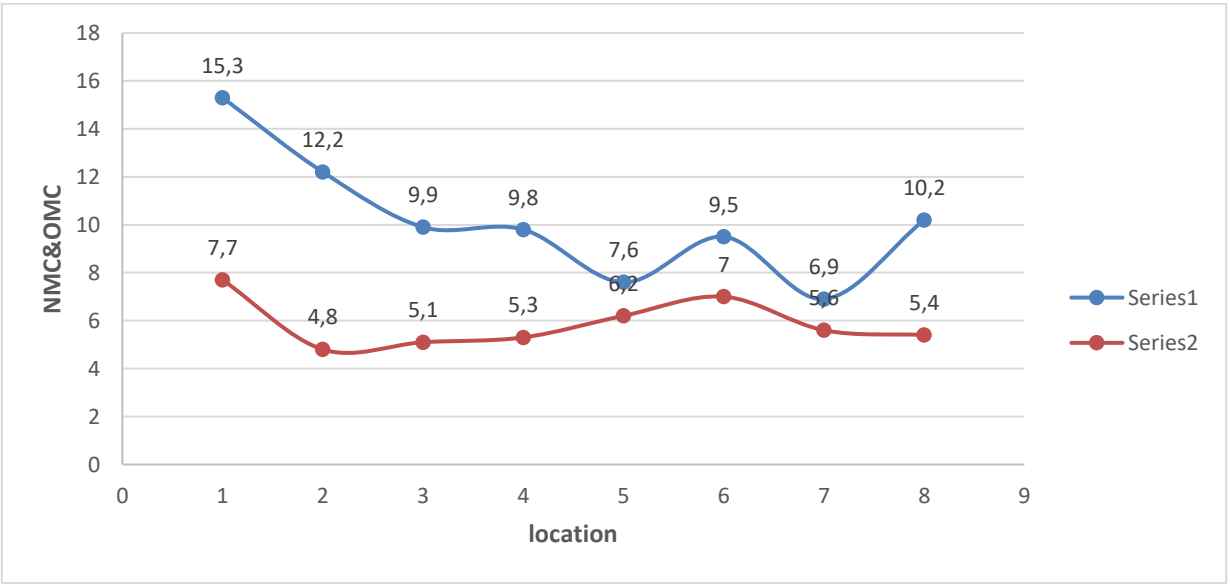
It is reasonable to state that, like in the failed section, it is unsuitable in the base of the sound Section. They are also mainly clayey materials, and it is observed that failure did not occur in these sound sections because the natural contents are below the optimum moisture contents even during the rainy season.
