Analysis of Pavement Failure (Flexible Foundation): A Case Study of Bauchi-Kaduna

Abdulmajid Ibrahim[1], Engr. Yusuf Yau[2], Ewemade Cornelius Enabulele[3]
[1,2]Ahmadu Bello University Zaria, Nigeria
[3]Federal University of Technology Akure, Ondo State, Nigeria
majd4real@gmail.com; yyau@abu.edu.ng

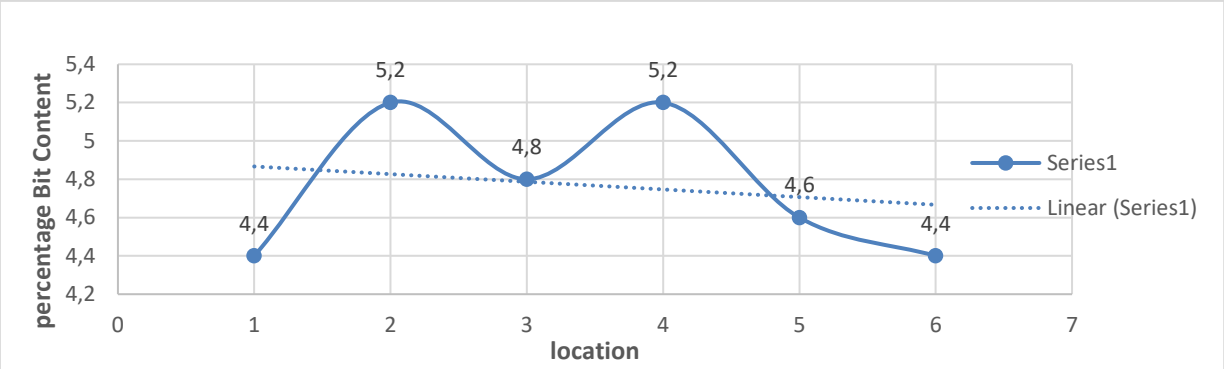
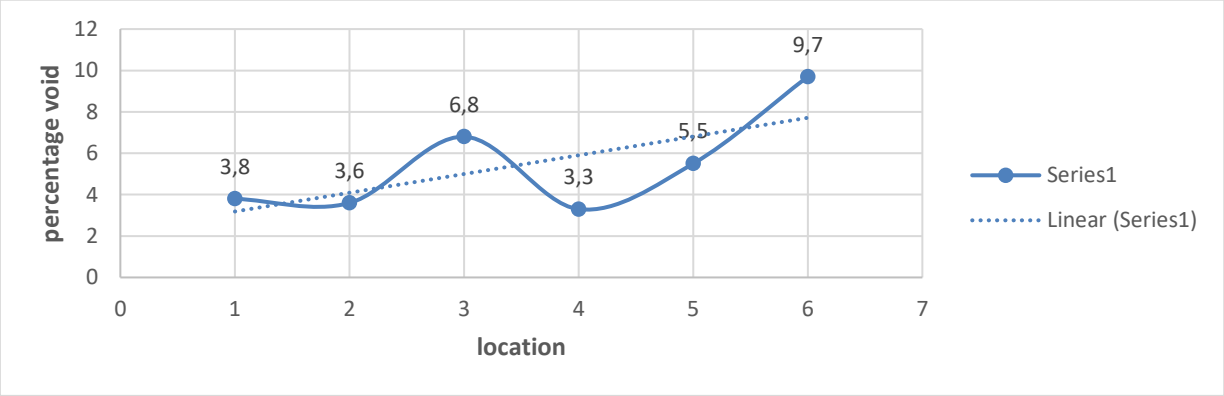
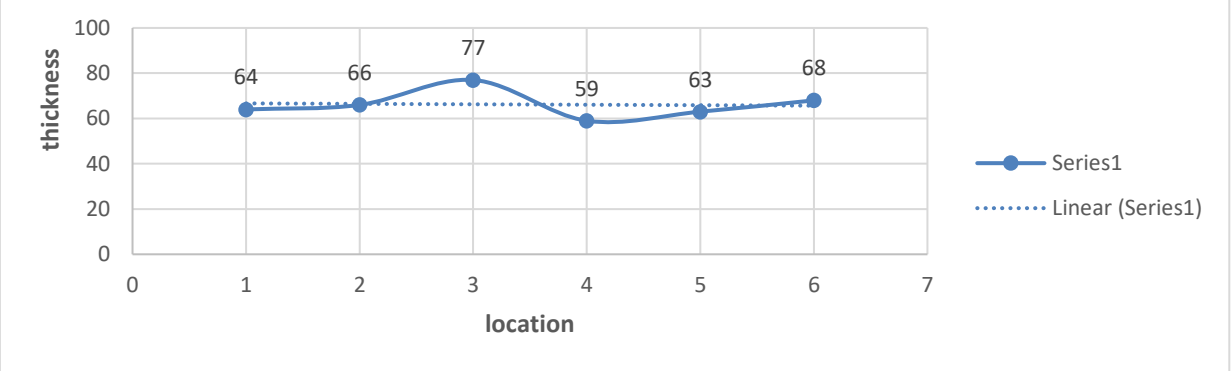
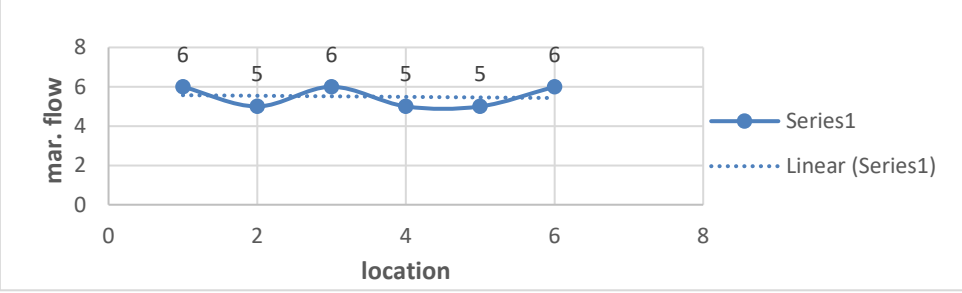
S/N	Location	Thickness	BDG	MSD	%Void	Mar.Stab	Mar. flow	BitCont,	Remark
1.	8+300	64	2.443	2.54	3.8	596	6	4.4	FAILED SECT
2.	8+600	66	2.525	2.438	3.6	708	5	5.2	FAILED SECT
3.	8+900	77	2.449	2.526	6.8	636	6	4.8	FAILED SECT
4.	9+200	59	2.433	2.525	3.3	532	5	5.2	SOUND SECT STIRLING
5.	9+500	63	2.392	2.531	5.5	441	5	4.6	FAILED SECT
6.	9+800	68	2.321	2.57	9.7	650	6	4.4	FAILED SECT

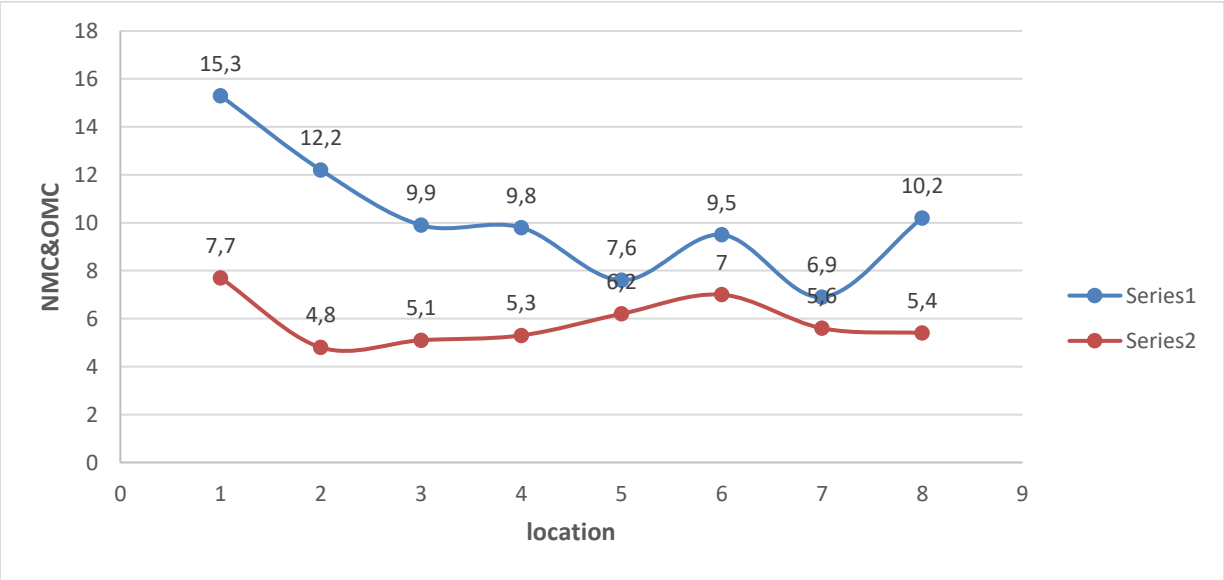
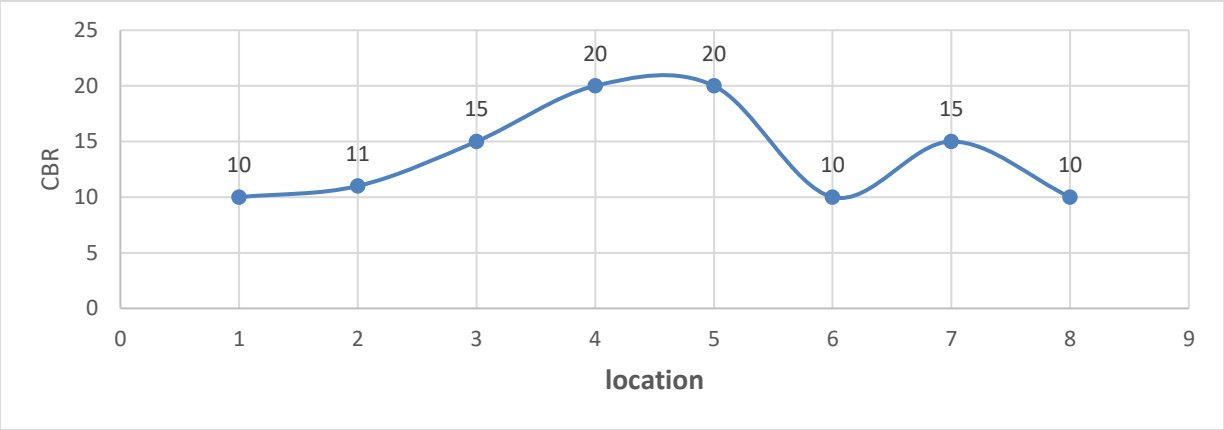
crack development. They also lose much strength in water, resulting in shear failure. It is shown in Soaking met average, while Compaction was achieved onsite.

It is reasonable to state that, like in the failed section, it is unsuitable in the base of the sound Section. They are also mainly clayey materials, and it is observed that failure did not occur in these sound sections because the natural contents are below the optimum moisture contents even during the rainy season.

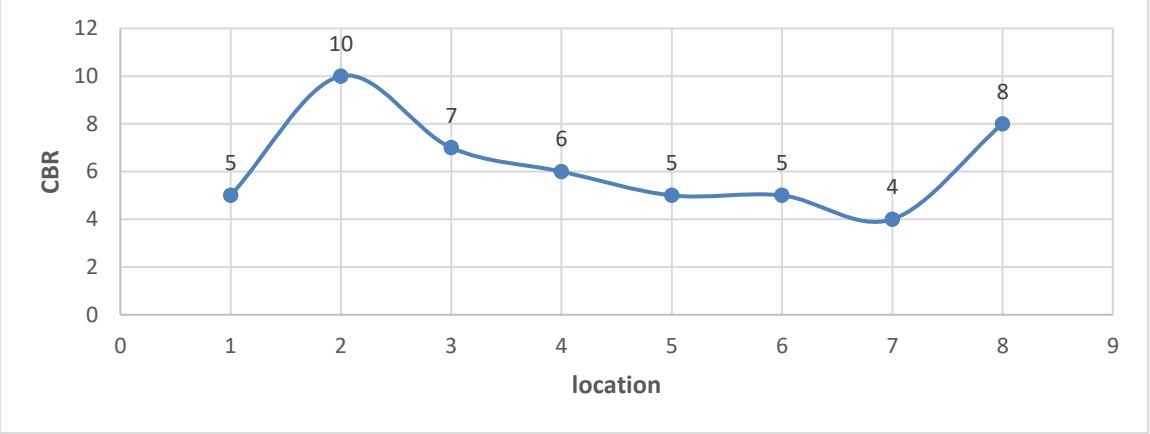
Figure 14: A graph of CBR against location

From the analyses, the subgrade soils encountered have acceptable levels of liquid plasticity index and subgrade in most locations. However, their particulars are too fine as the proportion passing BS Sieve No 200 was higher than in all the tested samples. They are mainly clayey soil of A-2-7, A-6, A-7-6, and AASHTO classification groups, which also undergo swelling and shrinkage characteristics upon variation in moisture contents.

It can be inferred that soil of the same characteristics was encountered in the sound and failed sections, but failure did not occur in sound areas because they were dry even under the rains due to good drainage and the use of suitable stone base.

It's recommended that open earth drainages should be provided at all locations, and subsoil drainage should be provided in another area where there is an imminent failure. The guidelines contained herein are recommended to be integrated into the Pavement Guide (2007). In addition, given that water was found to be seeping through existing, dense-graded I-MA layers, the Engineer should investigate the efficacy of installing surface drains within the existing, milled surface (similar in concept to wearing course surface drains) spaced at regular intervals along a project to provide transverse drainage paths for water that tends to flow longitudinally through the pavement.
