Analysis of Dyeing Process Quality at PT XYZ

Hestiani Rahayu & Yun Yun
Universitas Jenderal Achmad Yani, Indonesia
hestianirahayu23@gmail.com; yunyun@lecture.unjani.ac.id

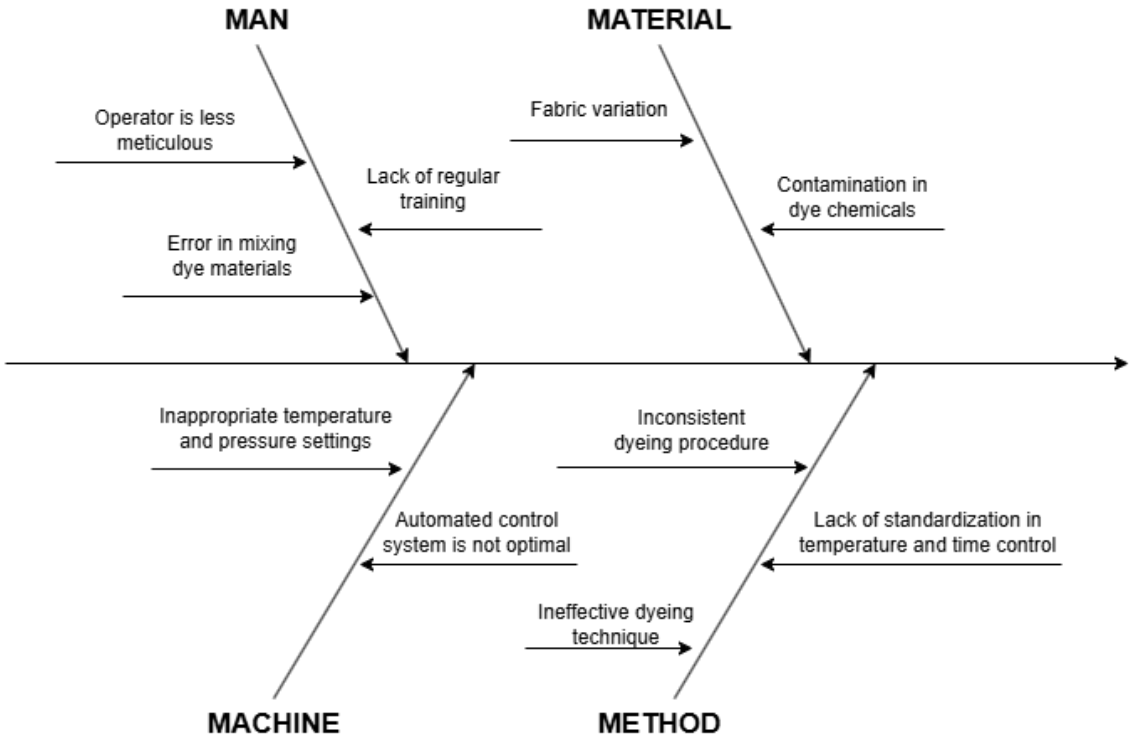
Figure 2. Diagram Fishbone

Based on the Fishbone Diagram presented in Figure 2, the causes of product defects in the dyeing process at PT XYZ can be categorized into four main interconnected factors: Human, Material, Machine, and Method. Each of these factors significantly contributes to the low quality of the final product and the inefficiency of the dyeing process.

In the Human factor, the operator's skills are a critical element. The lack of mastery in accurately controlling the temperature and dyeing time often leads to inconsistencies in the final results. This is further exacerbated by the absence of regular training that aligns the operators' knowledge with the company's desired standard operating procedures. Additionally, inaccuracies in the measurement of dye mixture, which heavily rely on the operator's precision, contribute to color variations that do not meet expectations. Without adequate skill development, the potential for human error in this process will continue to increase, affecting the quality of the produced products.

The Material factor plays a significant role in determining the success of the dyeing results. The varying quality of raw fabric can lead to differences in dye absorption, causing some areas of the fabric to absorb more color than others. Variations in the quality of dye

materials, such as differences in concentration or the formulation of chemicals used, also have a direct impact on the final dyeing outcome. Contamination in the dyeing materials, often undetected at the early stages, causes stains or uneven coloration on the fabric. The instability in material quality, both in terms of fabric and dye, highlights the importance of stricter material quality control to ensure optimal dyeing results.

The Machine factor is a technical aspect that cannot be overlooked in this analysis. Inconsistent machine settings, such as improper temperature and pressure control, can significantly affect the dyeing process. Suboptimal temperature and pressure prevent the dye from evenly penetrating the fabric, ultimately resulting in products with colors that do not meet the required standards. Additionally, machinery breakdowns that are not addressed promptly add to the complexity of the issue. The automatic control system, which is not yet fully optimized, also poses a challenge because the machine cannot operate efficiently without the operator's intervention. As a result, operators are forced to make numerous manual adjustments, which not only consumes time but also increases the likelihood of human error.

Finally, the Method factor indicates that inconsistent and insufficiently standardized dyeing procedures are the root cause of ensuring consistent results. Without clear standards for temperature settings, dyeing time, and dyeing techniques, variations in product outcomes are difficult to avoid. Additionally, the use of ineffective dyeing techniques to ensure even color distribution further exacerbates this issue. The lack of uniformity in dyeing procedures creates variability in the final results, which in turn affects the product defect rate. The absence of standardized procedures to guarantee the quality of the dyeing results makes it challenging for the company to achieve optimal results consistently.

By delving deeper into these four factors causing defects, PT XYZ can take more targeted corrective actions. Improvements in operator training, raw material and dye quality control, more proactive machine maintenance, and the standardization of dyeing procedures are essential solutions to reduce product defect rates. Therefore, this analysis not only identifies the problems but also paves the way for improvements that will enhance both the quality and efficiency of the dyeing process in the future.

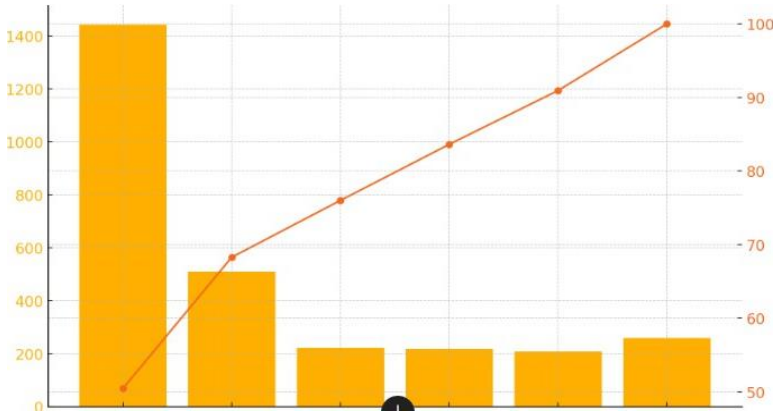
Figure 3. Pareto chart analysis

Based on the results of the Pareto chart analysis, it is evident that the most dominant defect in the dyeing process at PT XYZ is incorrect color, which contributes to more than 50% of the total defects that occurred. The dominance of this figure indicates that color mismatch is a critical issue that must be addressed systematically and comprehensively. To identify the root cause of this problem, a 5 Why analysis was conducted, illustrating the cause-and-effect chain in-depth until the main cause was discovered.

The analysis begins with the first question: why is the color incorrect? The answer is that the dye mixture was not prepared accurately. This inaccuracy arose from inconsistent dye dosing, which was traced further back to the discovery that the dye measuring equipment used was not accurate. The inaccuracy of the measuring tool was caused by the infrequent calibration process, and the root cause of all this was the absence of a Standard Operating Procedure (SOP) for routine calibration of the equipment. This cause-and-effect chain clarifies that the root problem lies in the weakness of the quality management system, particularly in the areas of equipment maintenance and control of the dye mixing process.

Therefore, the strategic solutions offered must not only be technical but also encompass system improvements. First, the calibration of dye measuring equipment should be scheduled regularly, at least once a month, to ensure the accuracy of measurements, which is crucial for successful color dyeing. Second, training for dye mixing operators is essential so that each individual involved understands the importance of accuracy in the mixing process and can identify color deviations early on. Third, the development and implementation of a new SOP, which specifically regulates the procedure for checking color

before the dyeing process begins, must be carried out immediately. This SOP will serve as an operational guide to ensure consistent quality and prevent the occurrence of color mismatches during dyeing.

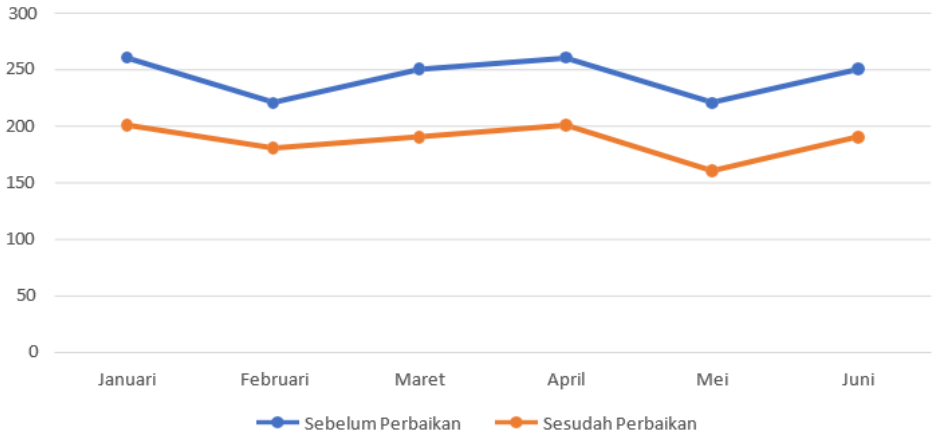
Figure 4. Trend of Defect Reduction

The evaluation of the effectiveness of the corrective actions implemented in the dyeing process at PT XYZ shows significant results. Based on the comparison data of six months before and after the implementation of corrective actions, which include the creation of the QC checklist, the establishment of the color mixing SOP, and operator training, there was a 22.6% reduction in the average color mismatch defects. This reduction reflects a real improvement in process control and enhanced output quality.

Specifically, in January, the number of color mismatch defects decreased from 261 cases to 200, which represents a 23.37% reduction. This positive trend continued consistently in the following months, with the highest reduction recorded in March at 24.00%, indicating that the quality control system and operator training were beginning to have a significant impact on production outcomes. Although there were slight fluctuations from month to month, the overall data demonstrated a stable downward trend, with every month showing a decrease of over 17%.

These results reinforce the assumption that the primary cause of defects, which was previously the incorrect color mixing due to uncalibrated measuring instruments and insufficient operator competence, has been effectively minimized through a systematic, data-driven approach. Furthermore, the establishment of SOPs and the implementation of a QC checklist played a crucial role in ensuring process uniformity and accurate execution on the shop floor. This, in turn, allowed for better control over potential deviations.
